Aging Effect on Marginal Gap Distance and Cyclic Loading of Two Different Ceramic Crowns

Prof. Dr. Cherif Adel Mohsen and Mostafa Elhussieny Mohammed Ismail

Abstract: This study was carried out to evaluate and compare the vertical marginal gap distance, and cyclic loading of all-ceramic crowns Vita suprinity and IPs e.max CAD (CAD/CAM milling, Cerec MCXL), using two types of finish lines (deep chamfer and radial shoulder). Specially designed stainless steel dies were constructed and a total number of 40 samples were constructed representing two equal groups (20 samples), according to the type of materials (VITA Suprinity and IPs E.max CAD “CAD/CAM milling technique Cerec MCXL) The twenty samples were further divided into two divisions (10 each) according to the type of the finish line used (deep chamfer and radial shoulder). Each division was then divided into two classes (5 each) (one class was constructed as a crown coping and then veneered, the second one was constructed as a full contoured crowns). Vita suprinity and IPs e.max CAD crowns were fabricated following a standard procedure and standard dimensions as controlled by the Cerec MCXL software. As regard the vertical marg

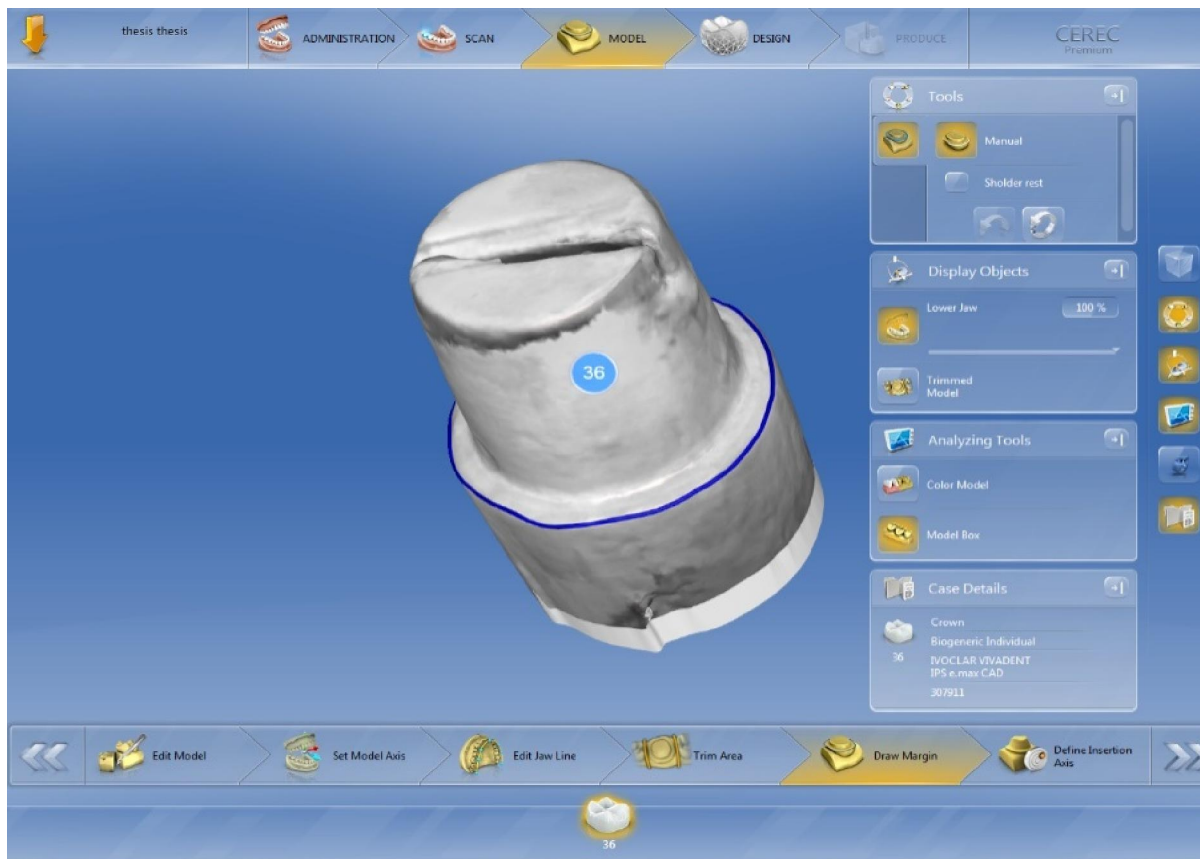
First design modes and restoration type were selected. Defining the margins is best accomplished manually. build the margins in small increments using the manual margination tool.

Using the scale, position and rotate tools allowed adjustment of the crown coping and fully contoured crowns dimensions according to the manufacturers recommended wall thickness which were 0.8mm for the coping and 1.2mm for the full contoured crown. the finished restoration was displayed in the milling simulation. The selected ceramic block of the required size (I12) was inserted in the spindle of the milling chamber of the CEREC MCXL system. This was followed by closure of the milling chamber door. The milling process run fully automated without any interference with the two diamond stones acting together simultaneously in the shaping process. The same process was repeated 20 times for each group to end with 40 milled restorations (20 crown copings and 20 fully contoured crowns).

Tracing of the preparation model margin Fitting of the crown copings:
